OptimFlush

Floor-standing Rimless Toilet

SATOFSHFS2

INSTALLATION INSTRUCTIONS

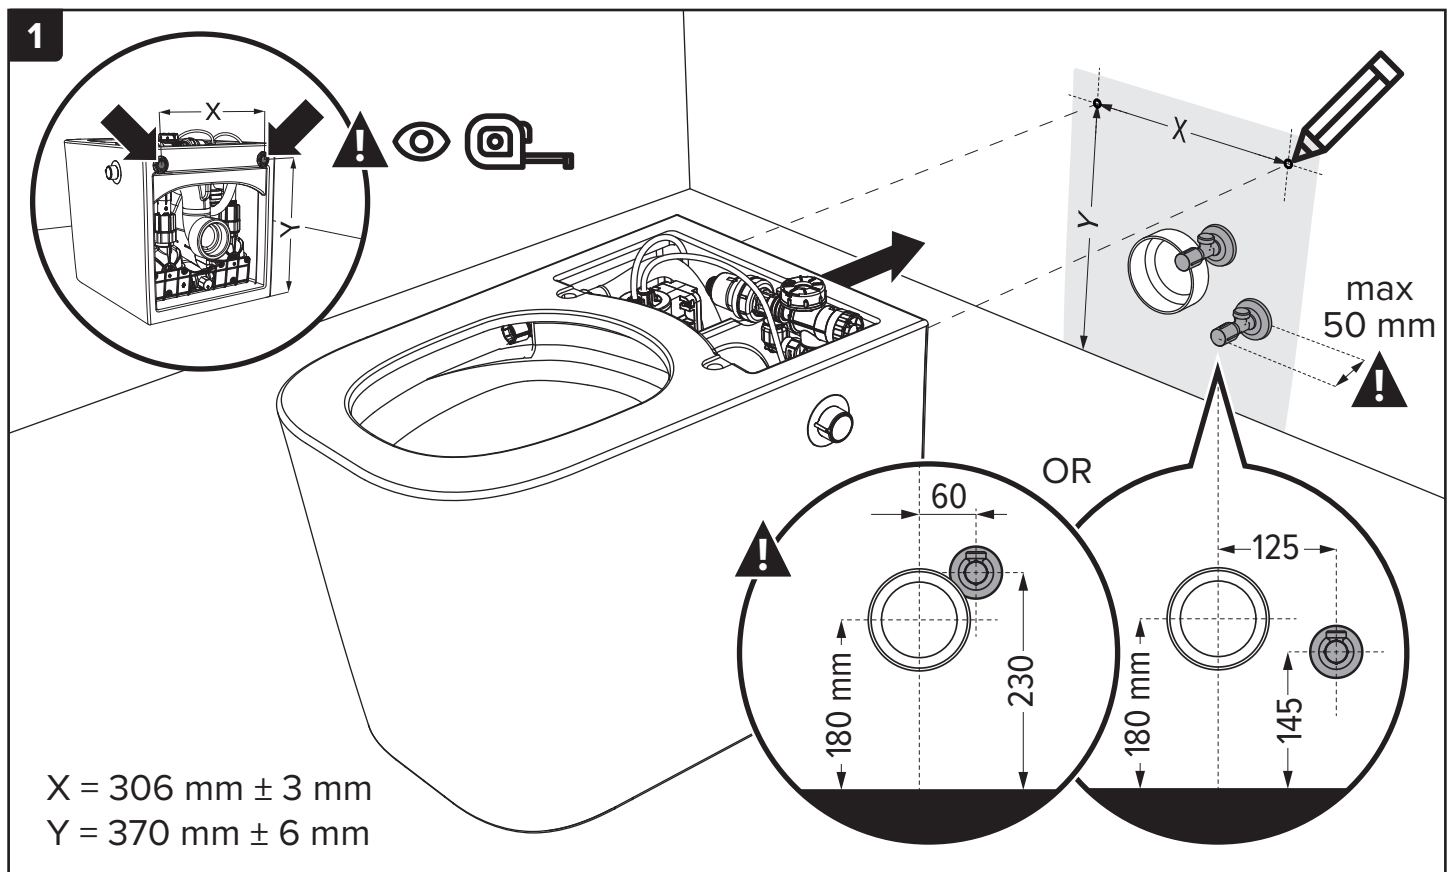
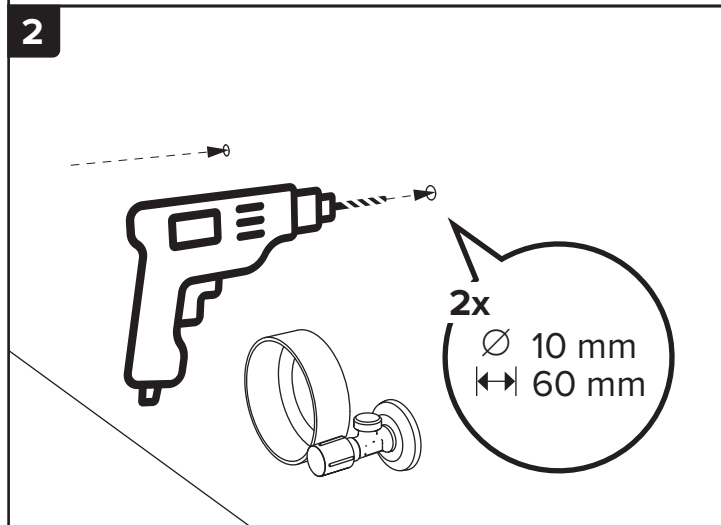
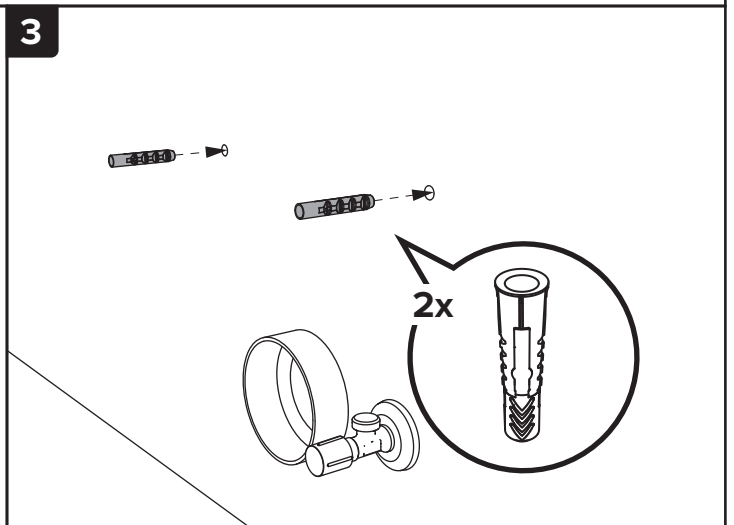
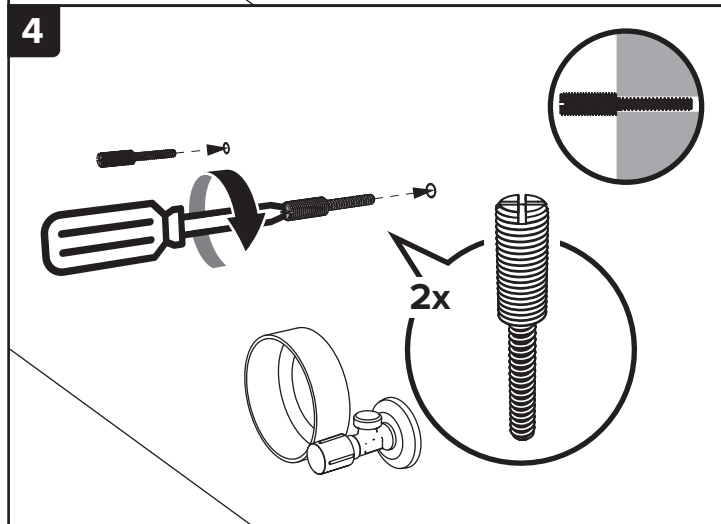
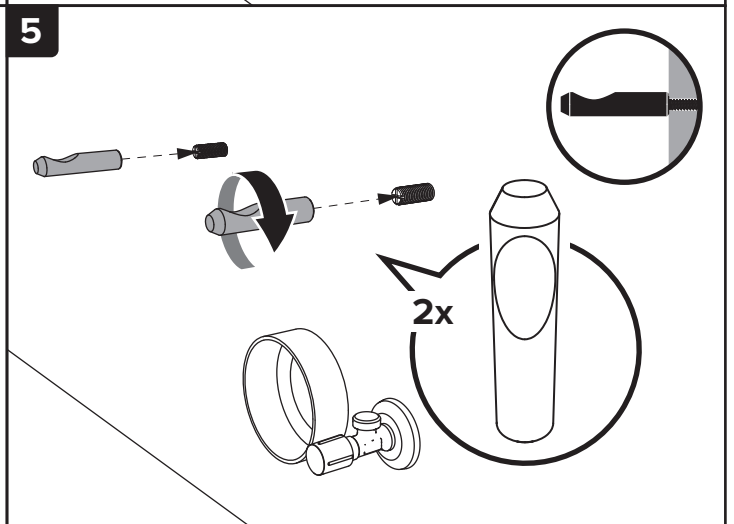
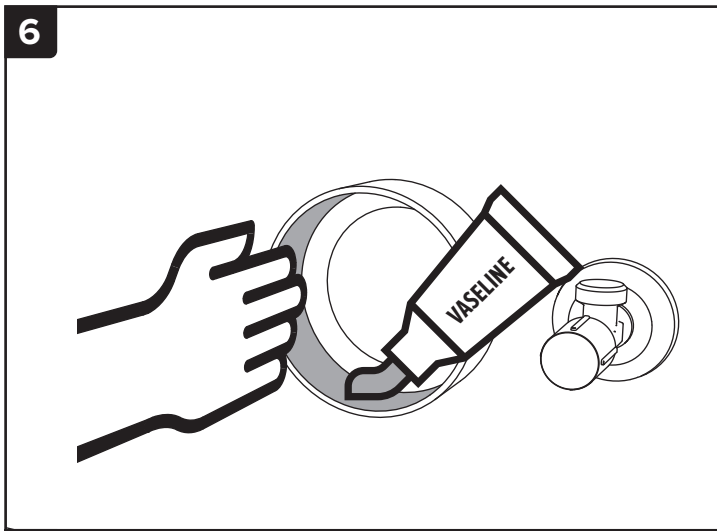
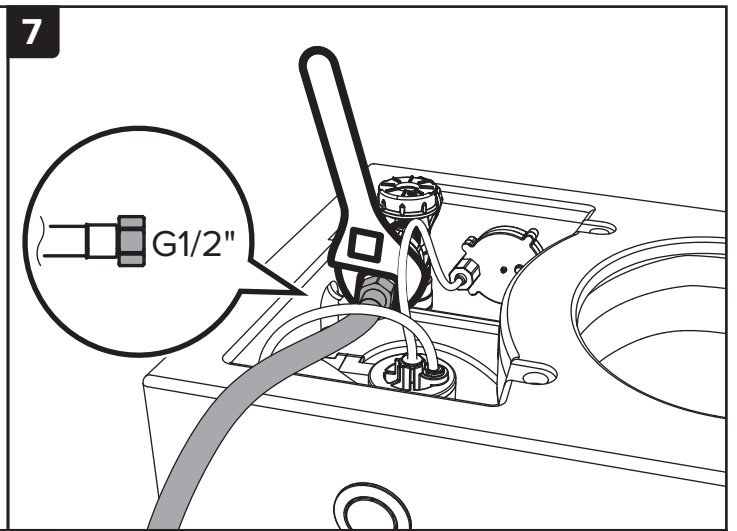
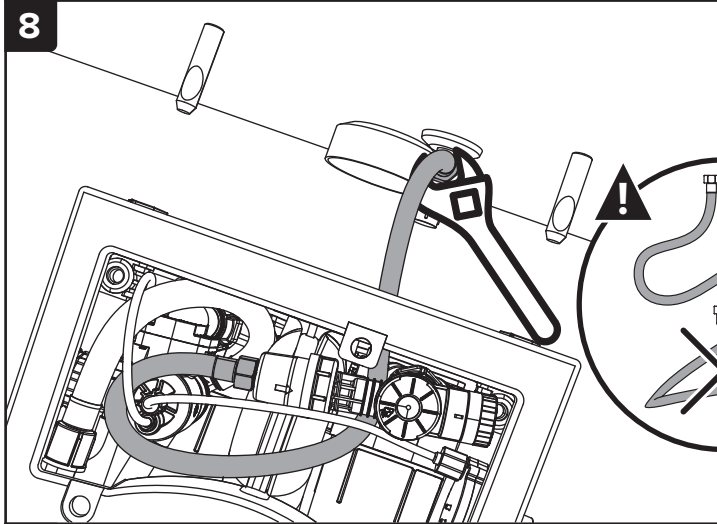
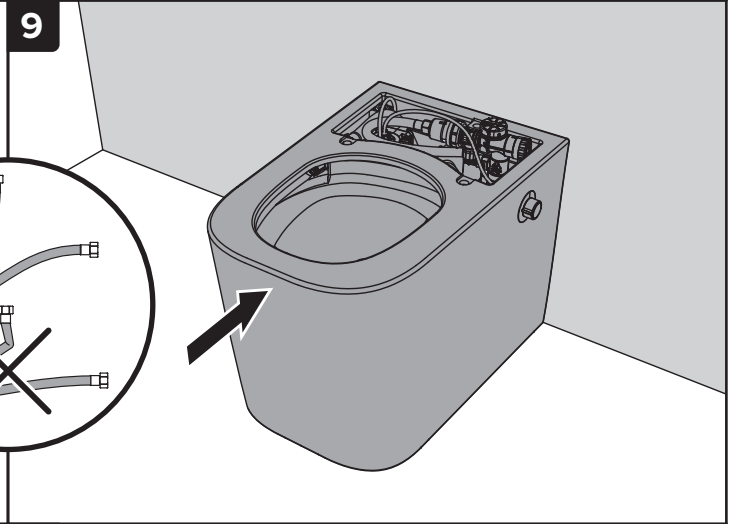
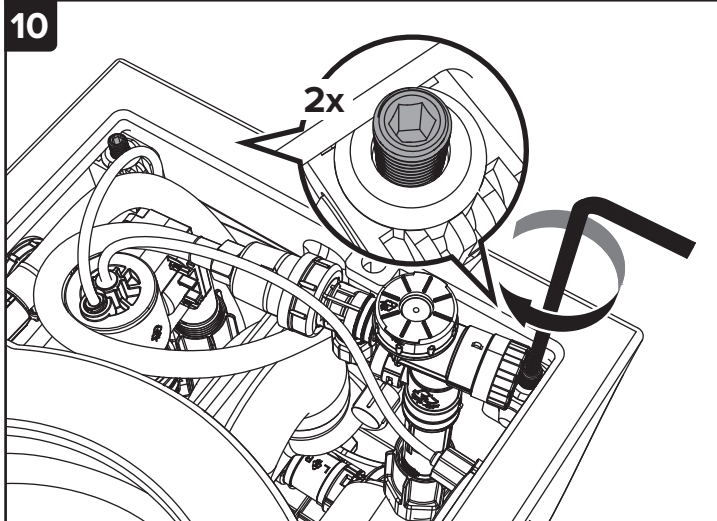
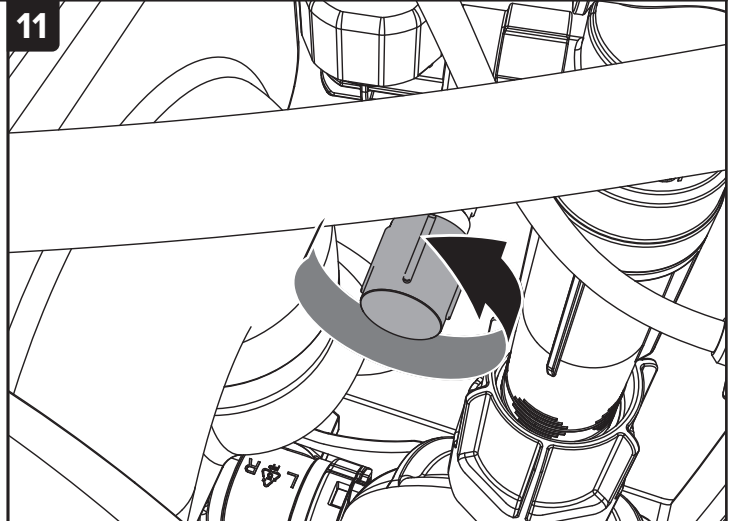
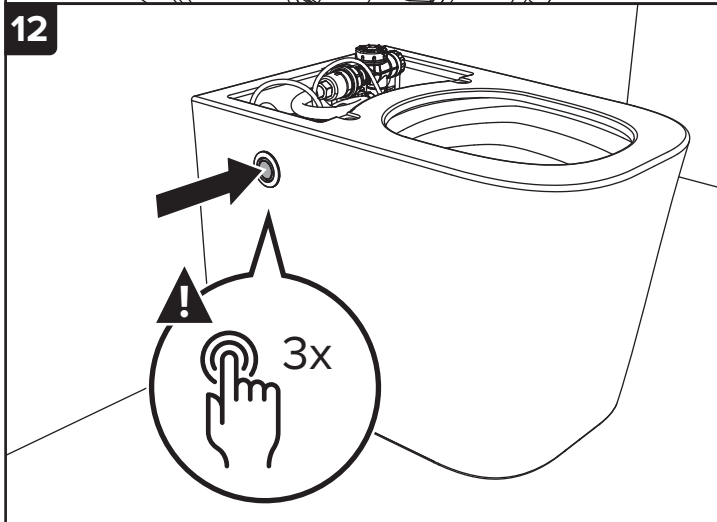
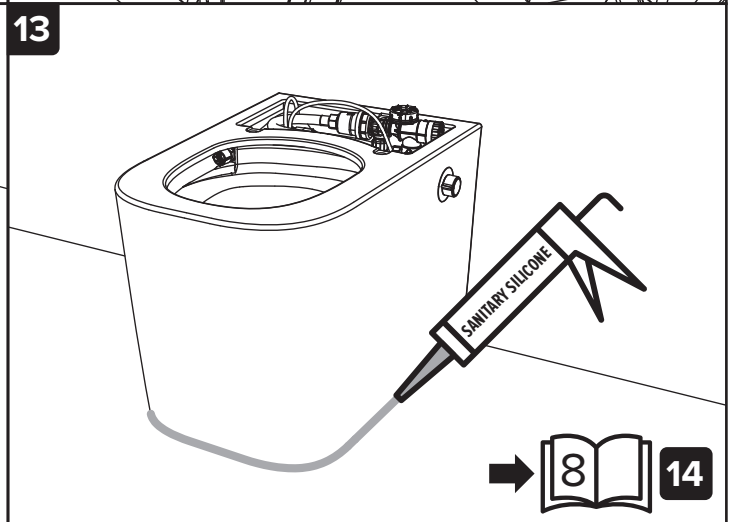
TOILET INSTALLATION

NOTE: Mounting surface must be clean and level before toilet is installed!

To avoid installation issue, please locate the wall mounting holes with the real ceramic hole, so they will be align with each other when lock.

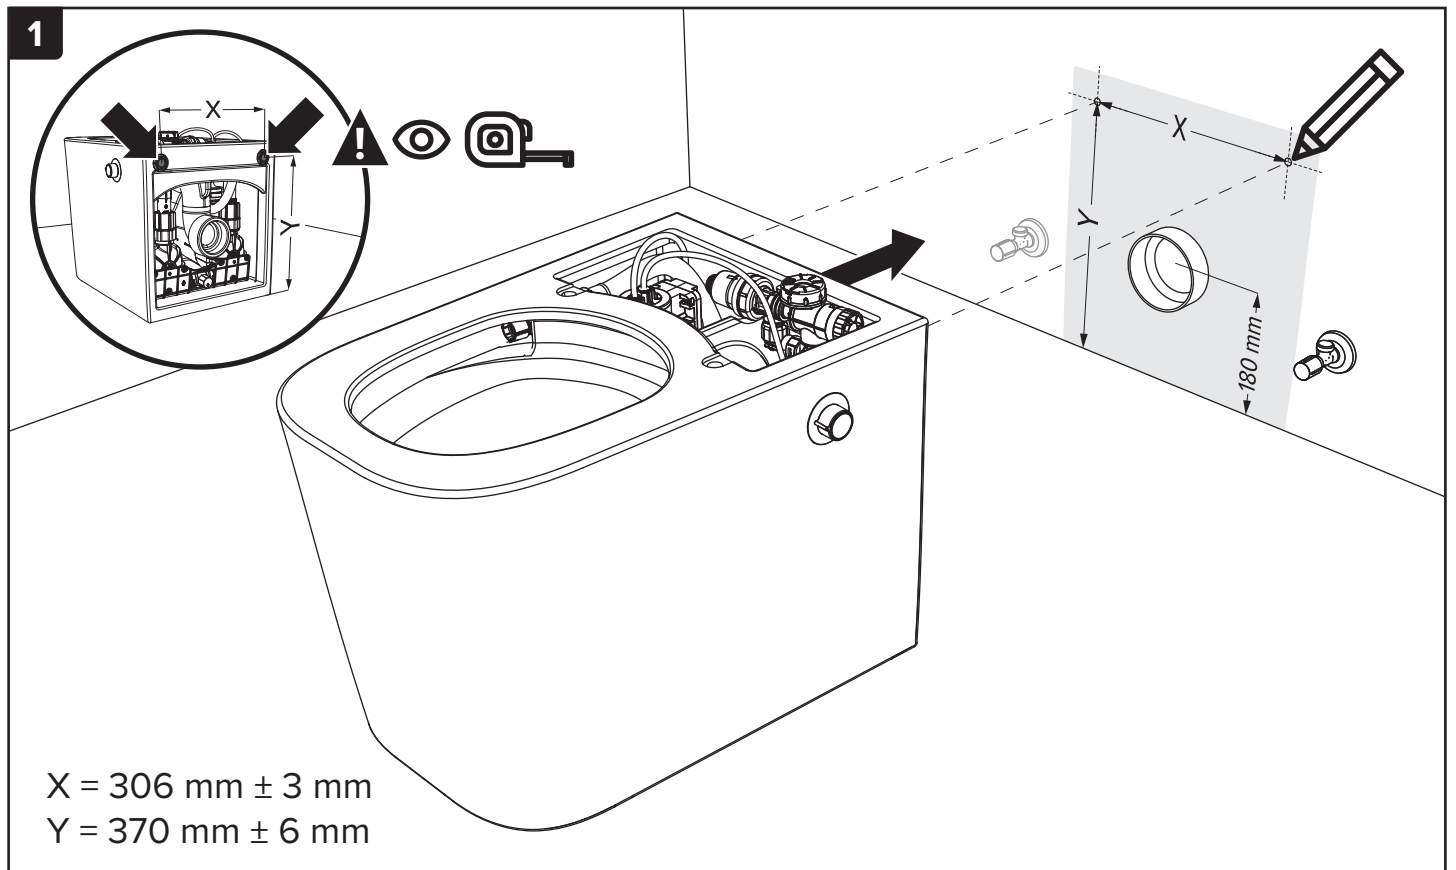
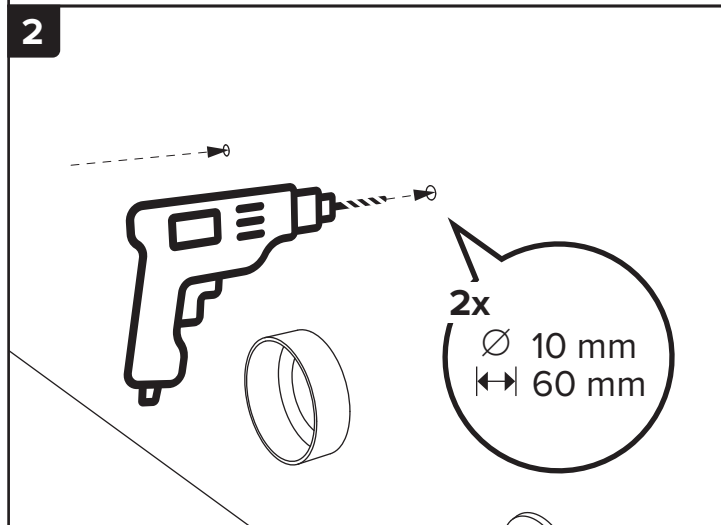
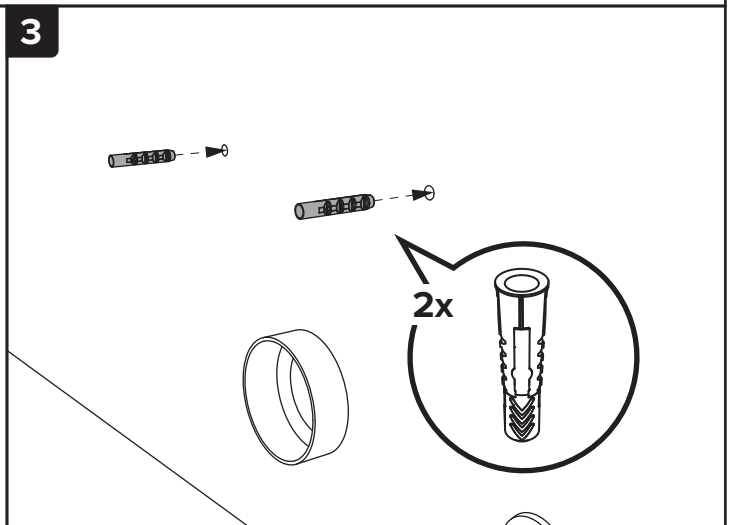
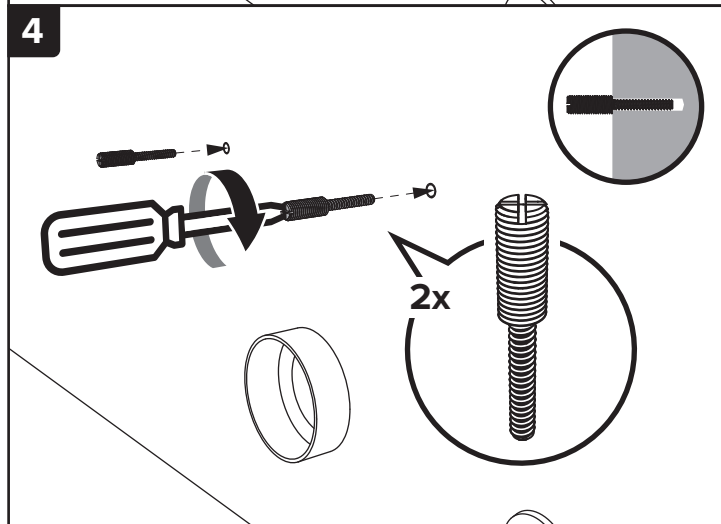
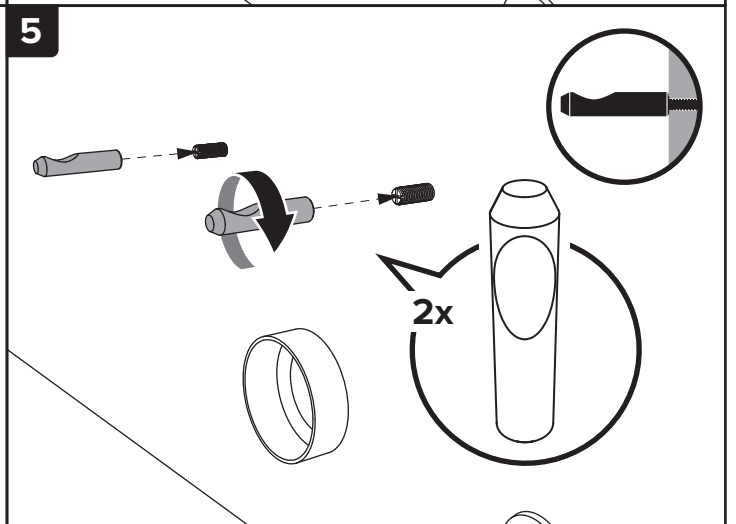
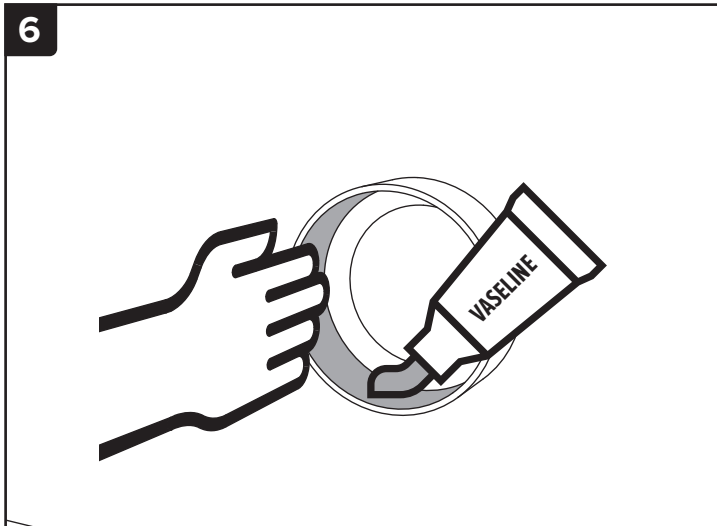
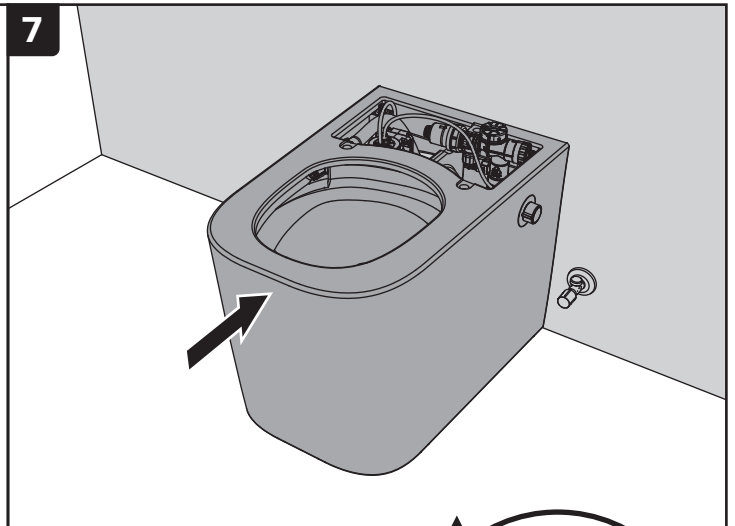
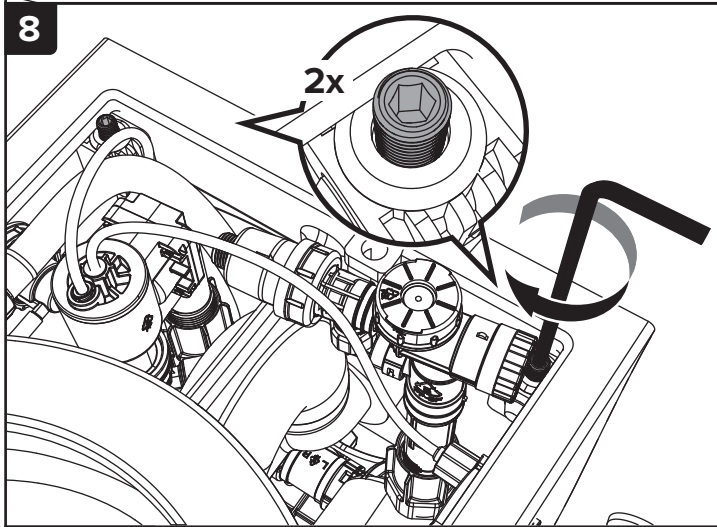
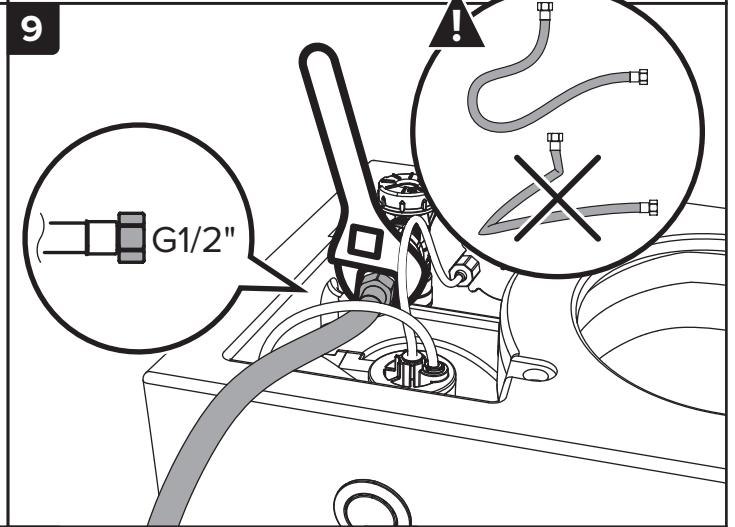
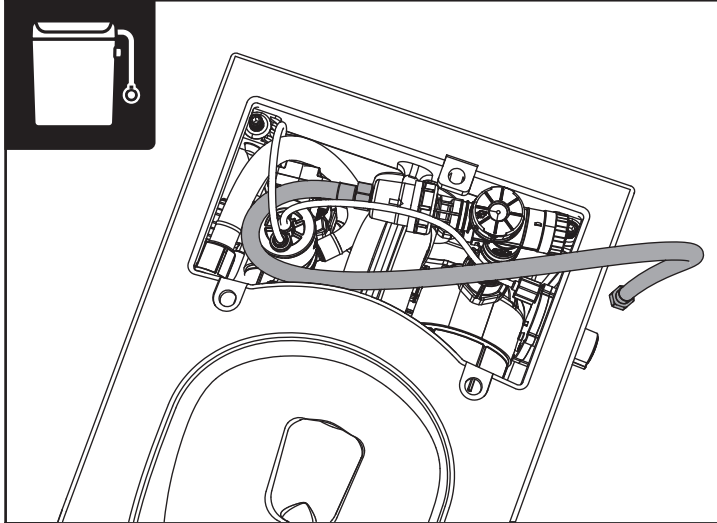
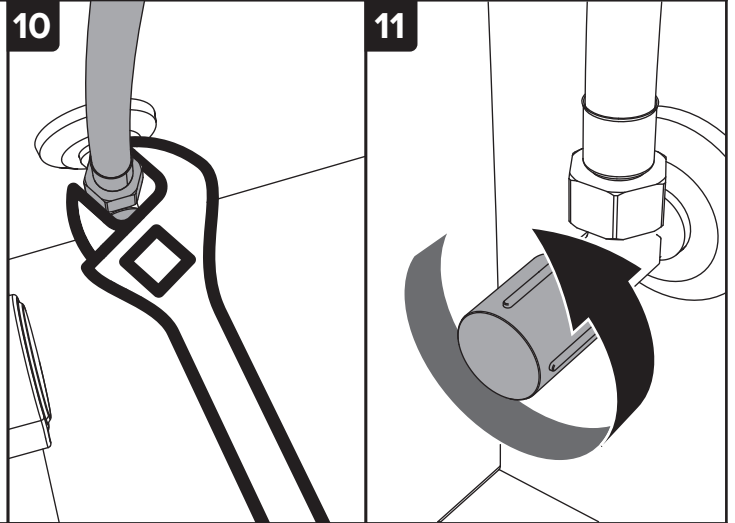
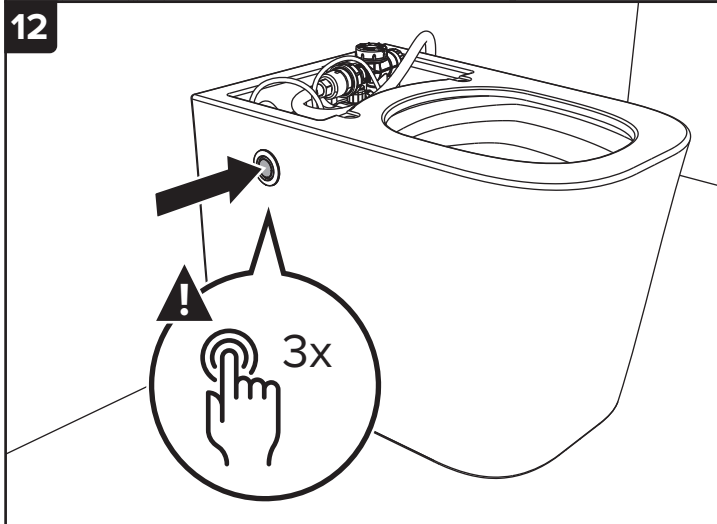
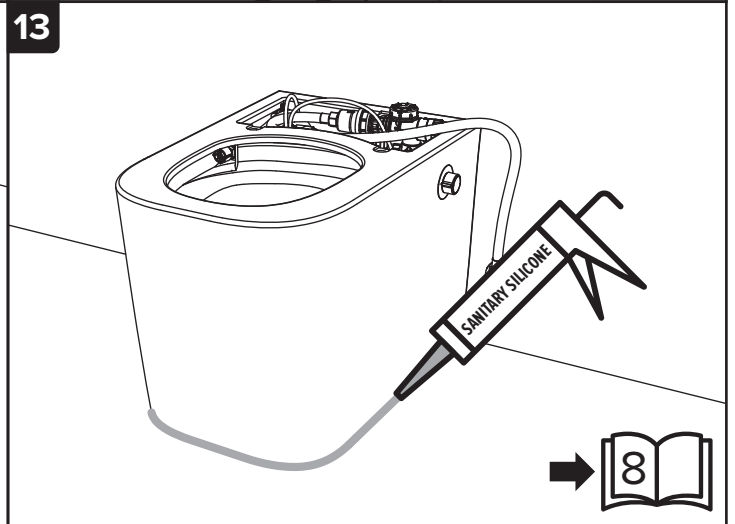
TOILET INSTALLATION

NOTE: Mounting surface must be clean and level before toilet is installed!

To avoid installation issue, please locate the wall mounting holes with the real ceramic hole, so they will be align with each other when lock.

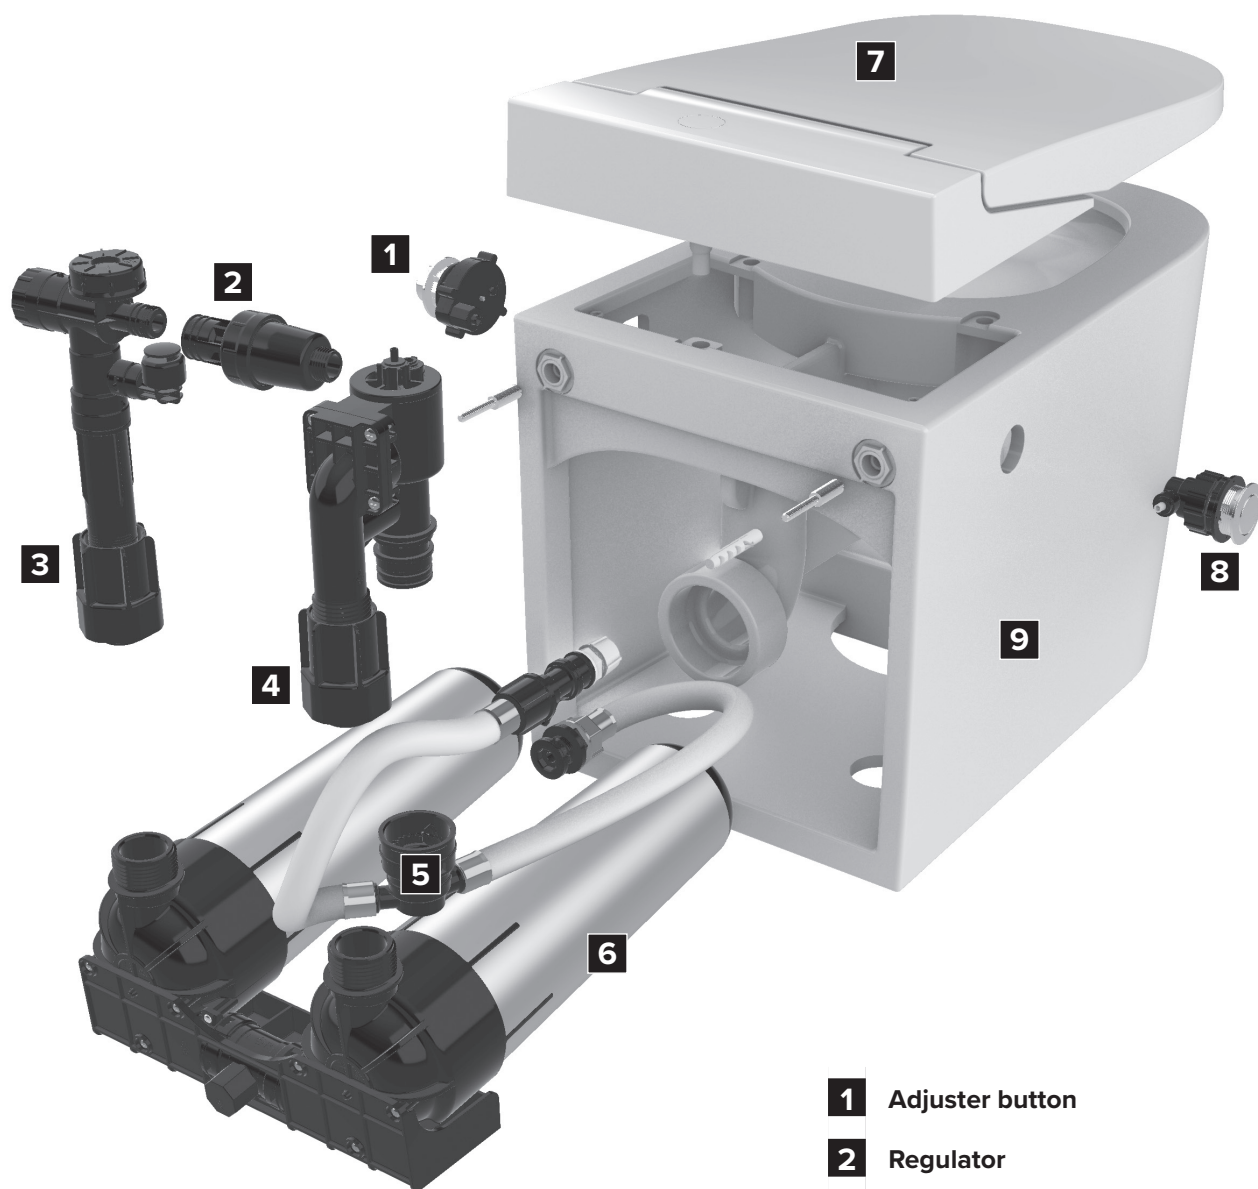
OFS TOILET PARTS

- 1** Adjuster button
- 2** Regulator
- 3** Fill valve
- 4** Flush valve
- 5** Water outlet pipe
- 6** Cartridges
- 7** Toilet seat
- 8** Flush button
- 9** Chinaware

No		Part Name	Part Number	Usage
1	 	Adjuster button	NDSATOFSHFS2AB	1
2	 	Regulator	999910060150	1
3	 	Fill valve	112070031020	1
4	 	Flush valve deck & core	112070031023 NDSATOFSHFS2FV	1
5	 	Water outlet pipe	NDSATOFSHFS2OP	1
6	 	Cartridges	NDSATOFSHFS2CA	1
7	 	Toilet seat	NDSATOFSHFS2SE	1
8	 	Hydraulic flush button	112070031021	1
9	 	Chinaware - ceramic toilet	NDSATOFSHFS2WC	1
